DEPARTMENT OF TRANSPORTATION

Contract #: 04-0120F4Cty: SF/ALA Rte: 80 PM: 13.2/13.9File #: 69.28**WELDING INSPECTION REPORT****Resident Engineer:**Pursell, Gary**Address:** 333 Burma Road**City:** Oakland, CA 94607**Report No:** WIR-002818**Date Inspected:** 31-May-2008**Project Name:** SAS Superstructure**OSM Arrival Time:** 700**Prime Contractor:** American Bridge/Fluor Enterprises, a JV**OSM Departure Time:** 1700**Contractor:** Zhenhua Port Machinery Company, Ltd (ZPMC), Changxing Island **Location:** Shanghai, China**CWI Name:** C.H. Chen**CWI Present:** Yes No**Inspected CWI report:** Yes No N/A**Rod Oven in Use:** Yes No N/A**Electrode to specification:** Yes No N/A**Weld Procedures Followed:** Yes No N/A**Qualified Welders:** Yes No N/A**Verified Joint Fit-up:** Yes No N/A**Approved Drawings:** Yes No N/A**Approved WPS:** Yes No N/A**Delayed / Cancelled:** Yes No N/A**Bridge No:** 34-0006**Component:** OBG**Summary of Items Observed:**

Segment 18A-008

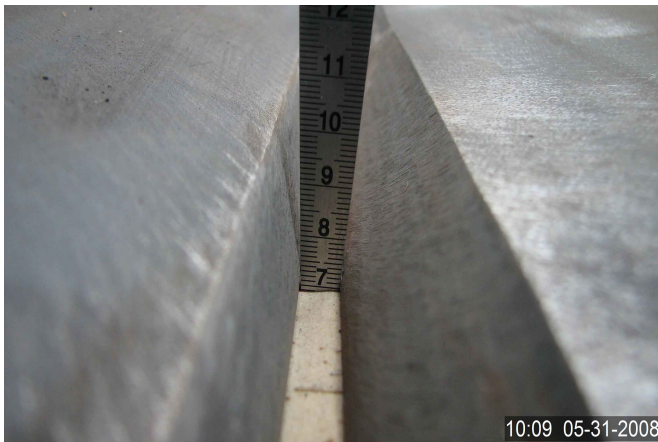
The Quality Assurance Inspector randomly performed an inspection of the fit-up of complete joint penetration weld joining Bottom Plate 18A to Side Plate 31A. The Quality Assurance Inspector measured the root opening to be approximately 5 to 7 millimeters and the bevel angle to be approximately 40 degrees. Below is a digital photograph illustrating the root opening and the use of ceramic backing utilizing a taper gauge. The Quality Assurance Inspector observed ZPMC welding operator Hong Yong Li, welder identification number 044801, performing in process welding of a complete joint penetration weld joining Bottom Plate 18A to Side Plate 31A. Quality Control Inspector C.H. Chen was monitoring the welder. The welder was using the flux cored arc welding process to produce the weld in the flat position. The Quality Assurance Inspector witnessed the Quality Control Inspector measure the welding parameters at the welder's station and found the parameters to meet the minimum requirements of welding procedure specification WPS-B-T-223(2)IT. The Quality Assurance Inspector witnessed

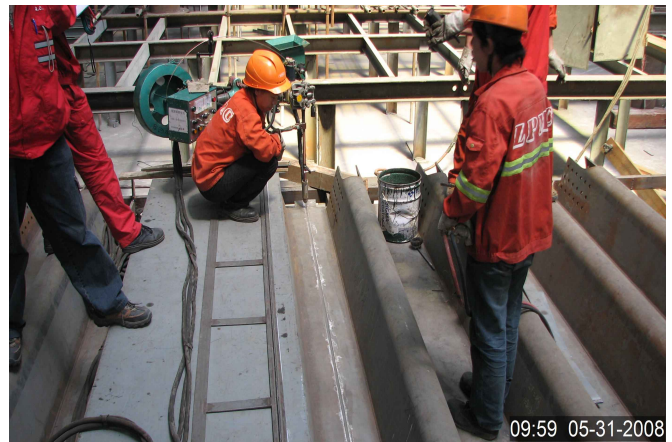
The Quality Assurance Inspector observed ZPMC welding operator Wang Lan Ying, performing in process welding of a complete joint penetration weld joining Deck Panel DP-014-001 to DP-060-001. Quality Control Inspector C.H. Chen was monitoring the welder. The welder was using the submerged arc welding process to produce the weld in the flat position. The parts were stationary while the welding machine was tracks to facilitate welding along the length of the part, The Quality Assurance Inspector witnessed the Quality Control Inspector measure the welding parameters at the welder's station and found the parameters to meet the minimum requirements of welding procedure specification WPS-B-T-2221-B—S-1. The Quality Assurance Inspector witnessed Quality Control measuring the interpass temperature using a calibrated infra-red temperature measuring device. Below is a digital photograph illustrating the welding in progress.
